Manhole Inspection Summary

Manhole # S06AA2013MH

Location Address: **3801 FALLSTAFF RD**

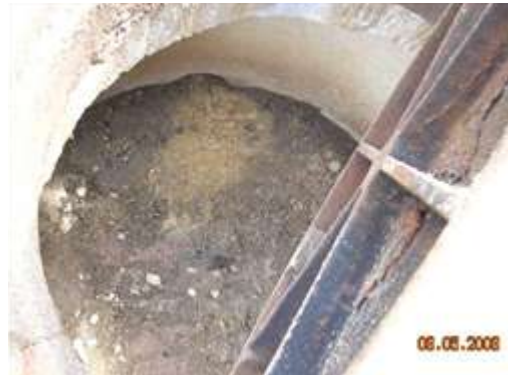
Top View

Channel debris.

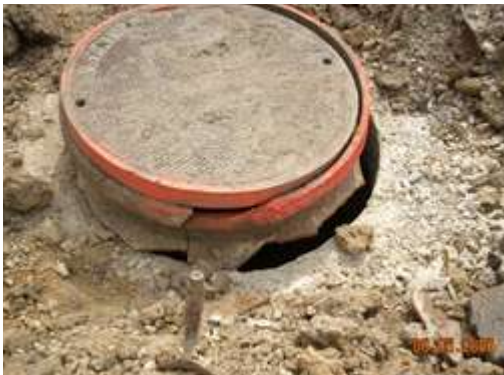
MH Damage

Comments **The MH area (a school) is under constrction. The MH frame and lid are damaged and the pipes are filled in with mud. Only able to get an O12 pipe pic. 08/05/08**

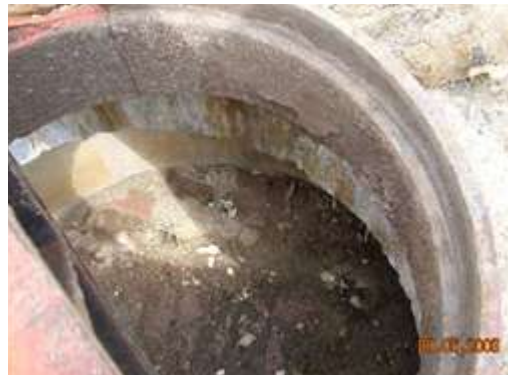
Defect

Frame leaks. Cracked frame. Corbel and Barrel infiltration.

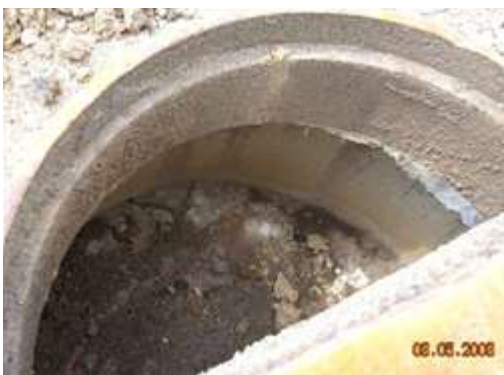
Defect

Frame leaks. Corbel infiltration.

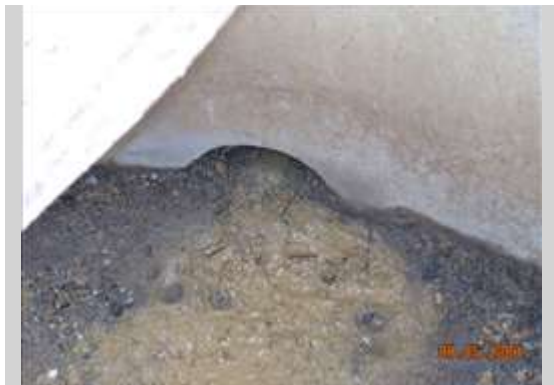
Pipe Out @ 12 O'Clock

Deposits: ☐ None ☒ **Mud** ☐ Sludge ☒ **Debris** ☐ Grease

Silt Depth: **3** (in.) Deposits Extent: **Medium**
